An Investment Casting Institute Publication

Atlas of Casting Defects

December 2017

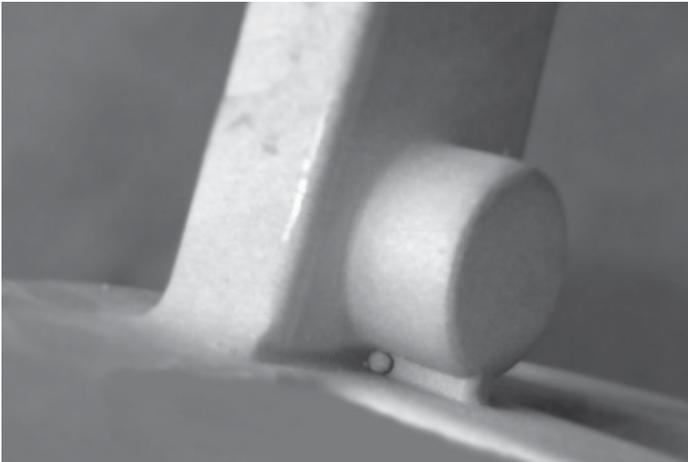
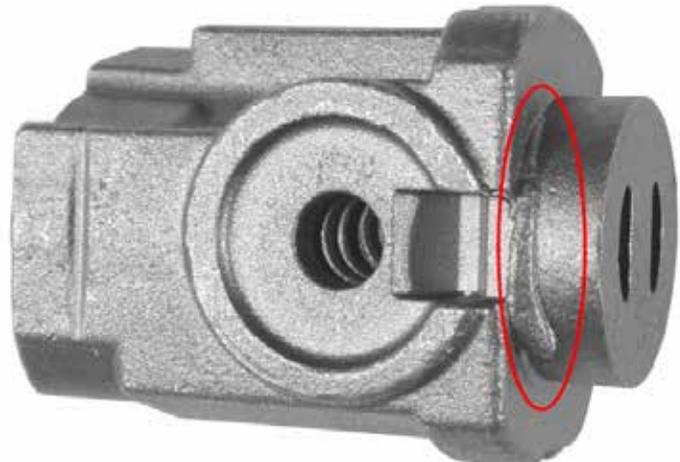
Bubbles

Air trapped against the wax pattern by the primary slurry layer

Visible to eye. Smooth surface of defect

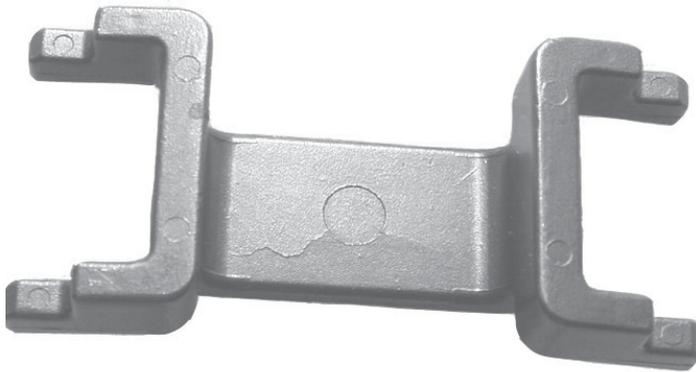
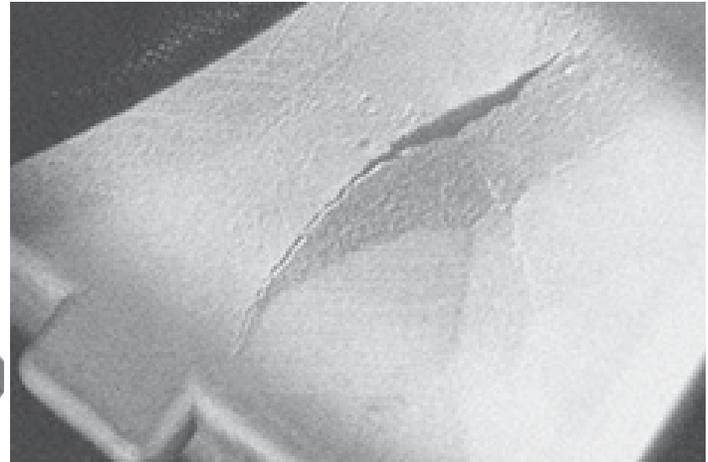
Buckle

The bond strength of the primary layer to the wax patten is insufficient and the primary layer buckles (lifts) off the pattern. The bond strength can be insufficient for a number of reasons including stress on the primary layer as it shrinks during drying.

When a shell buckles, it only separates from the pattern. With prime coat lift, the shell also fractures, allowing the backup layers to fill the gap between the primary layer and the wax pattern

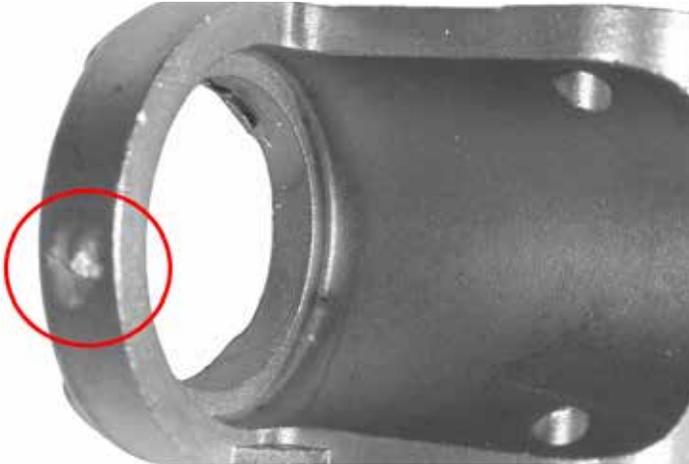
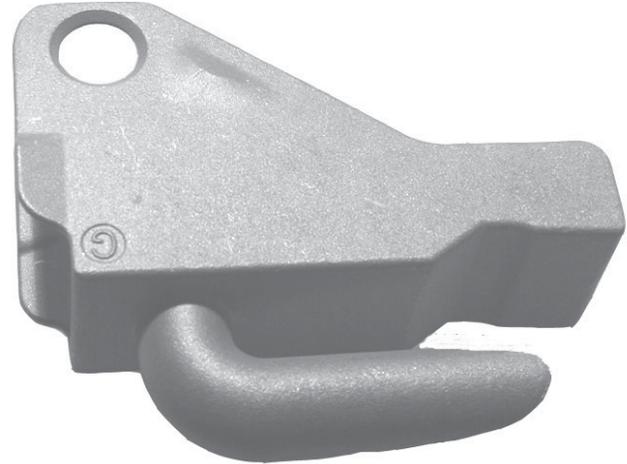
Bulge

Permanent deflection of the mold wall either during dewaxing or casting.

Similar in appearance to shell [buckle](#) but it doesn't have the definitive shape of a crack in the casting.

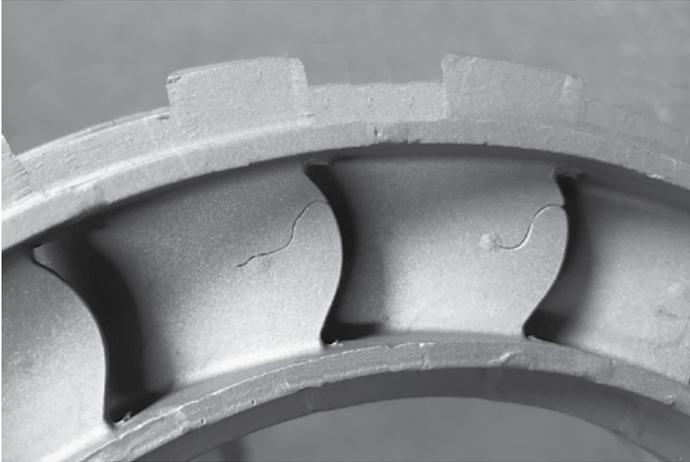
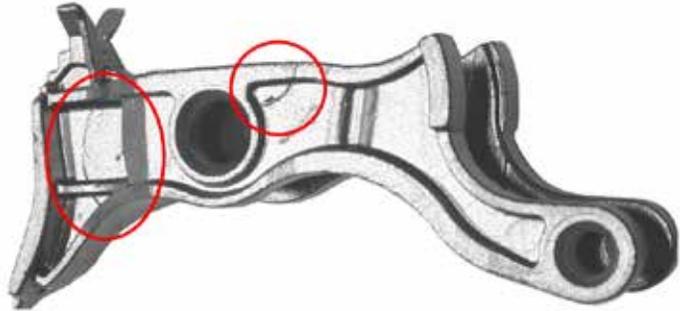
Cold Shut

Incomplete joining of two metal fronts

Smooth, linear, shallow, rounded edged impression extending into feature wall. This defect takes the form of a crack or discontinuity in the surface with rounded edges indicating the freezing or solidification of two or more streams of metal before they had time to completely fuse together.

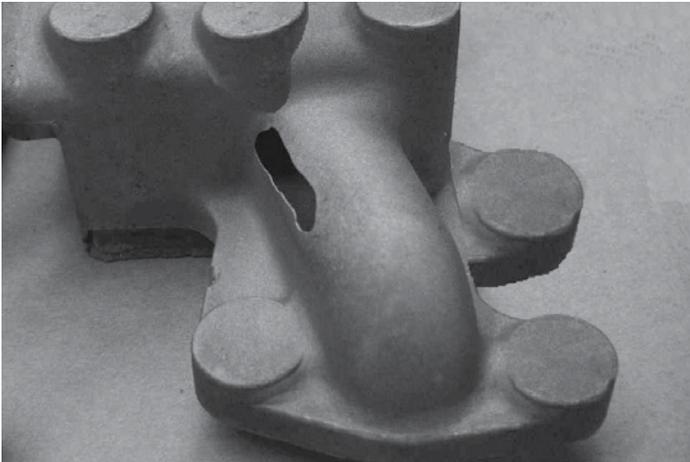
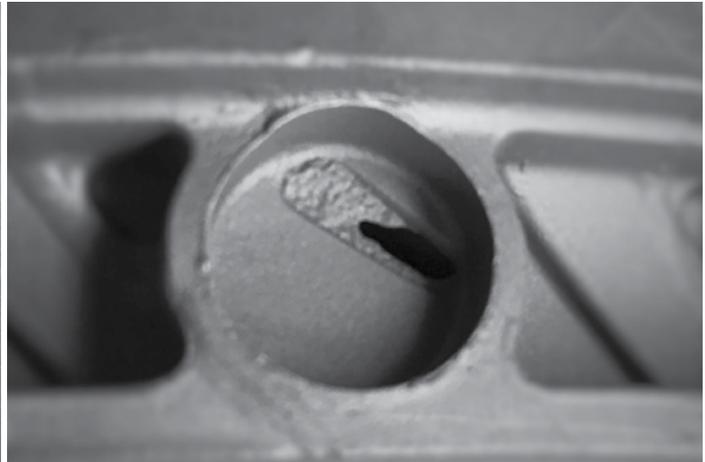
Core Breakage

Core breaks either during wax injection, during mold heating, or metal pouring

Metal fin across an area that is formed by a ceramic core. In the case of core break and shift, missing metal where a wall should be.

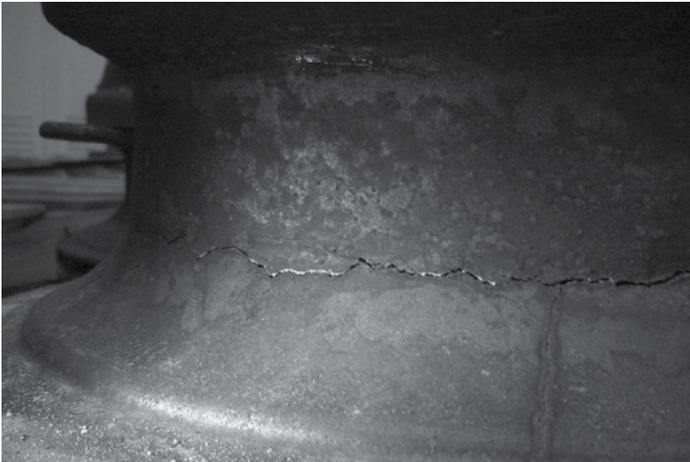
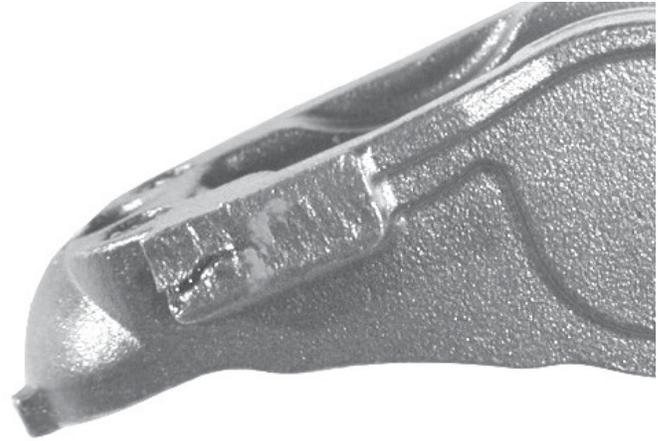
Typically, internal stresses from solid-state cooling or rapid cooling can cause cracking.

Jagged crack with irregular path

Visual inspection and Penetrant inspection typically reveal cracks. Cracks form roughly 90° to stress direction.

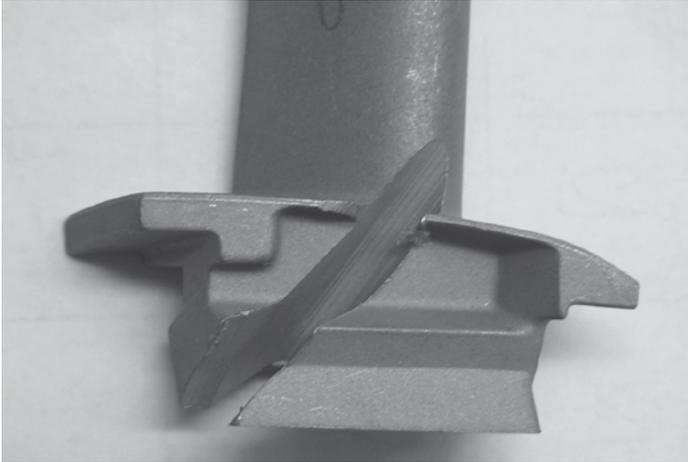
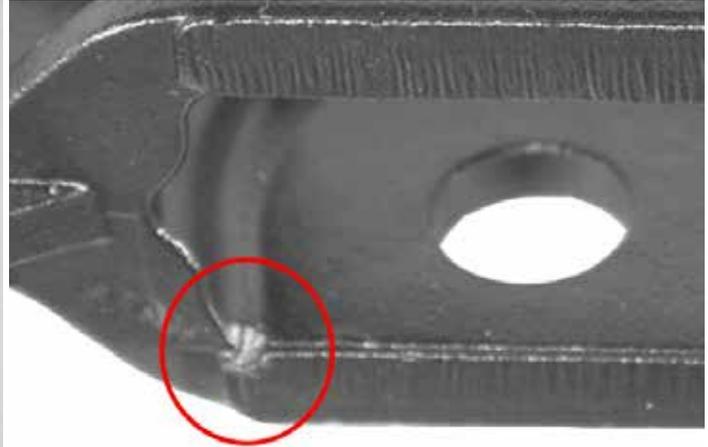
Cut-off Damage

Blade or plasma torch deflects into casting or continues into casting after cut

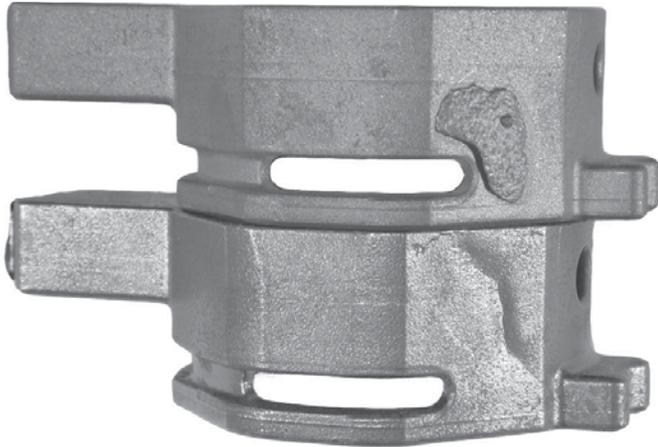
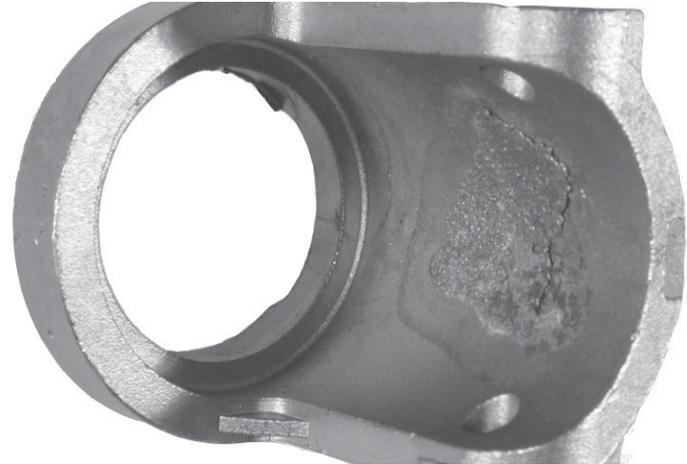
Delamination

Failure of bond between 1st and 2nd layer of shell. The first layer is pushed or pulled into the mold cavity usually during dewax. Sometimes the shell cracks and metal fills the gap between the layers producing a scab.

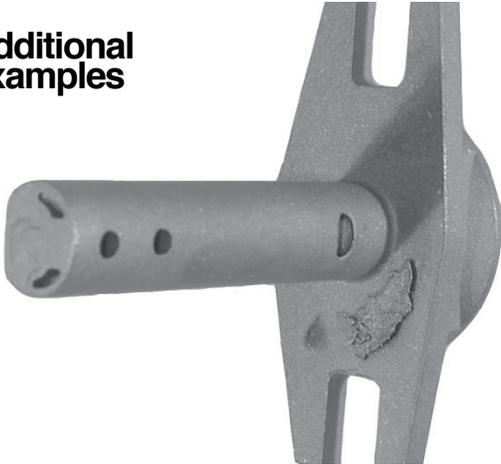
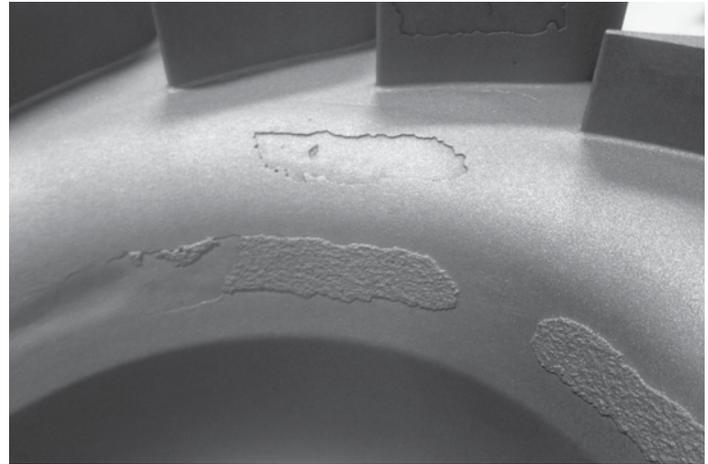
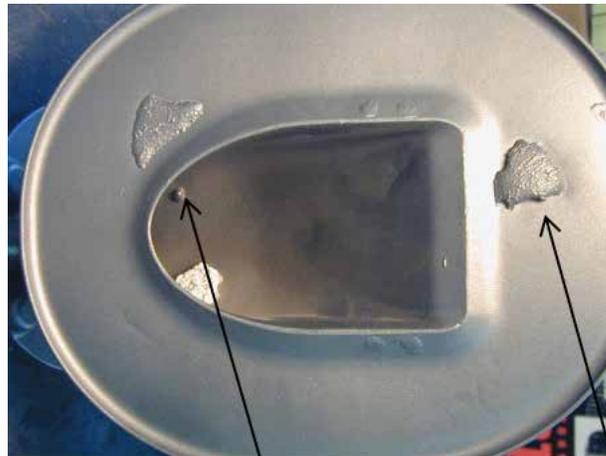
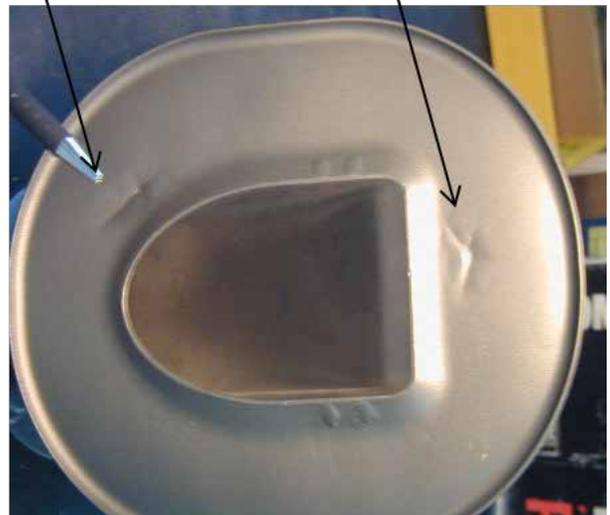
Delamination

Additional
examples

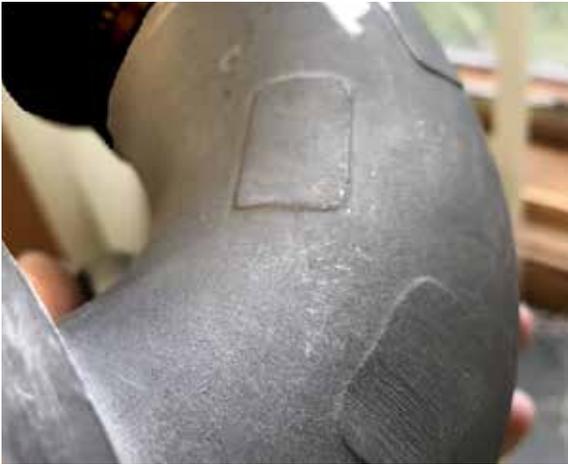
Distortion

Figure 1
Raised pads are witness to gating locations on the outside of the tube casting.

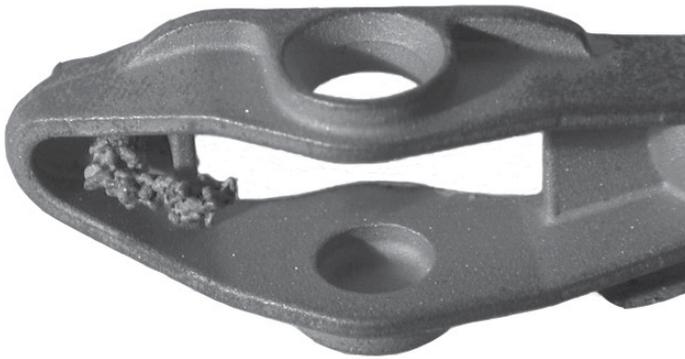
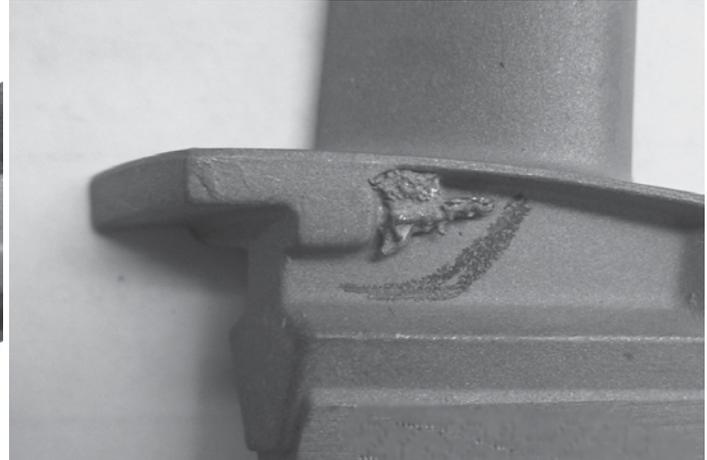
Excess Metal

Thin or weak areas of the shell fail during dewax or casting allowing metal to leak into the void in the shell.

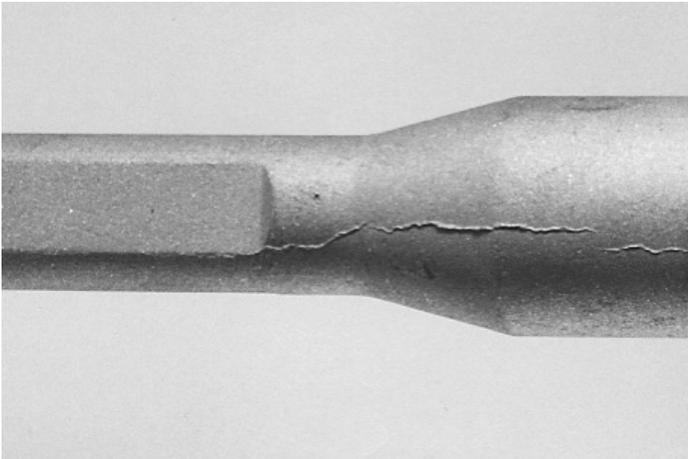
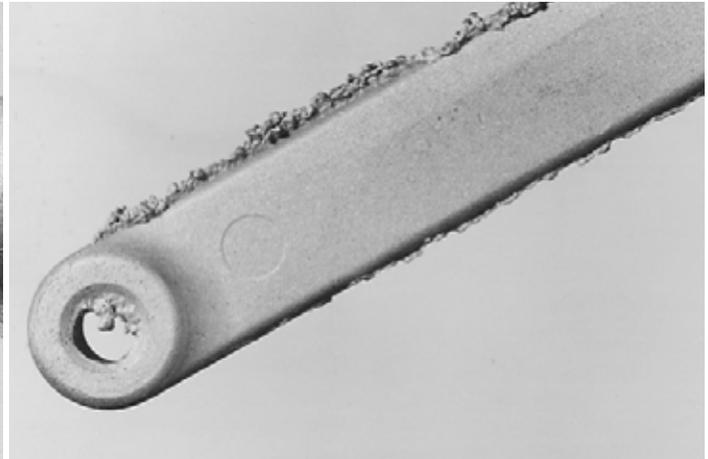
Shell crack during shell building, drying or dewaxing, and molten metal fills the crack during casting. Cylindrical shapes are more prone to this defect due to hoop stress

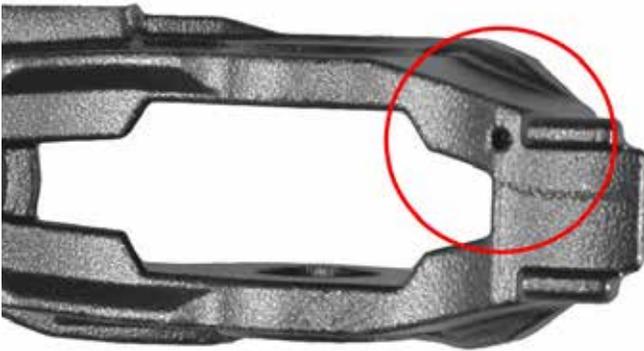
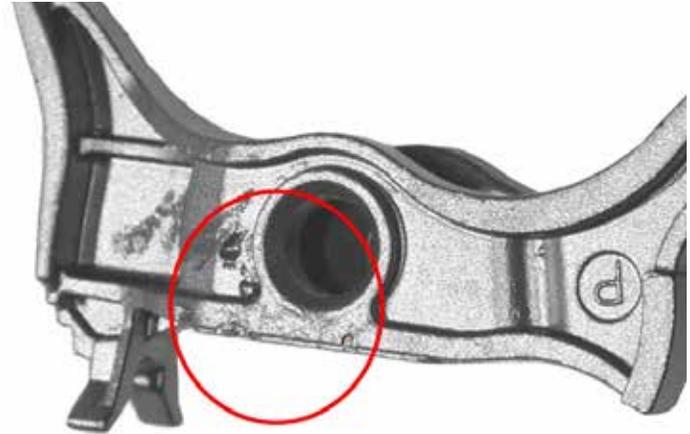
Mechanism

During casting, turbulent flow mixes the air that is exiting the mold with the metal that is entering. These bubbles float to the surface of the metal but are trapped by the solidifying metal. (Like air bubbles trapped under a layer of ice). This also can be caused by incomplete burnout of the wax and filler material in the mold, igniting when the molten metal reaches this material. Gas defects can also be formed when ceramic cores out-gas, or the strengthening materials (such as binders or superglue) applied to cores, burns out (usually associated with low preheat temperatures). Low permeability of molds is another cause of entrapped gas.

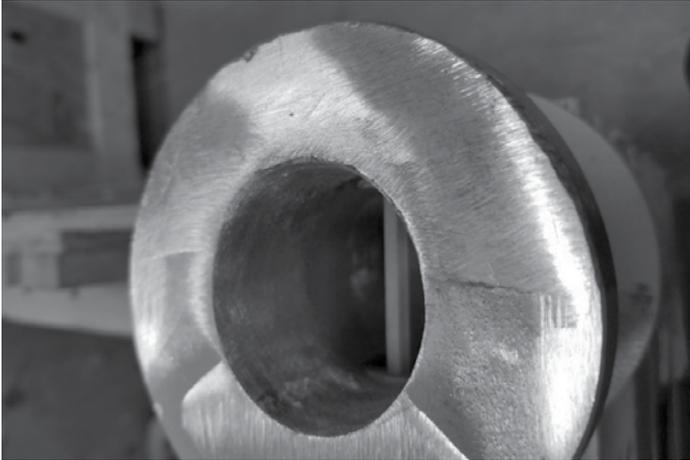
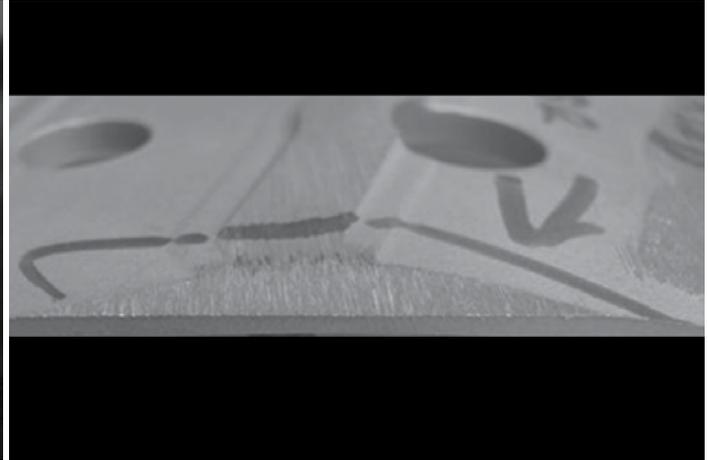
Grinding Damage

Mechanism

Abrasive grinding belt or wheel continues grinding into casting after removing the gate

Missing features or low wall thickness with linear serrations

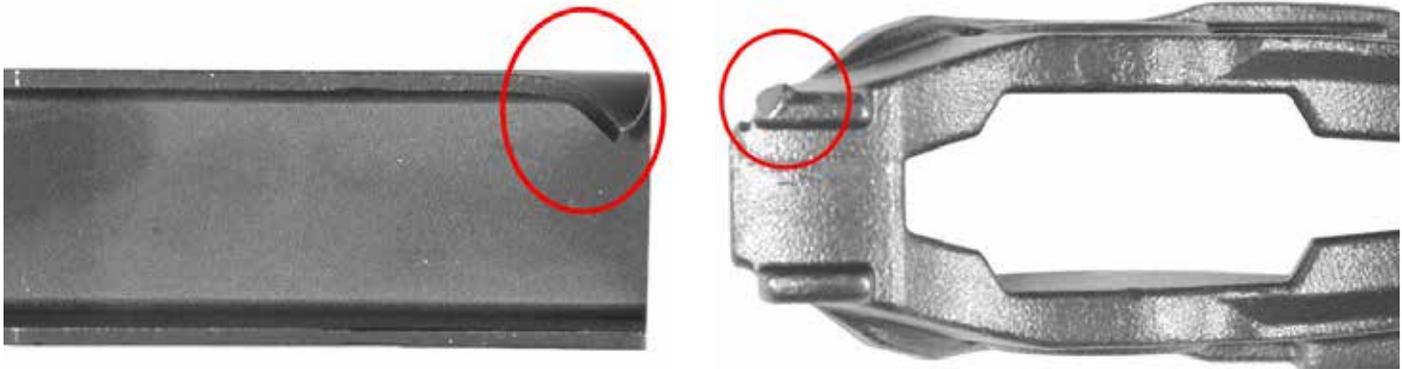
Handling Damage

Mechanism

Castings are damaged at some point after solidification

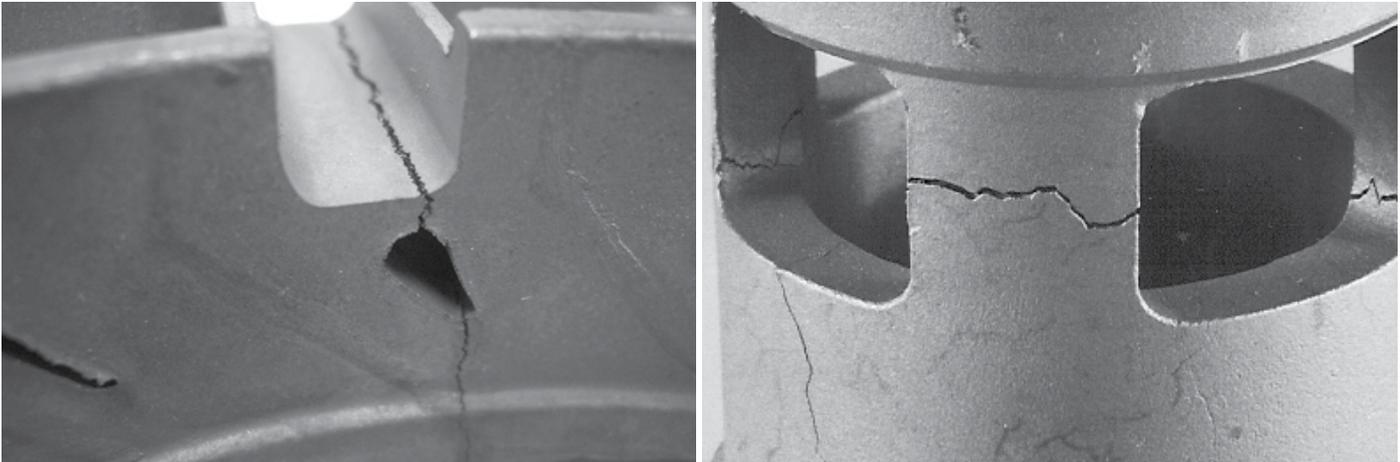
Mechanism

During casting cooling, the strength of the shell or gating system exceeds that of the solidifying metal

Jagged crack with irregular path, typically with an oxidized fracture face

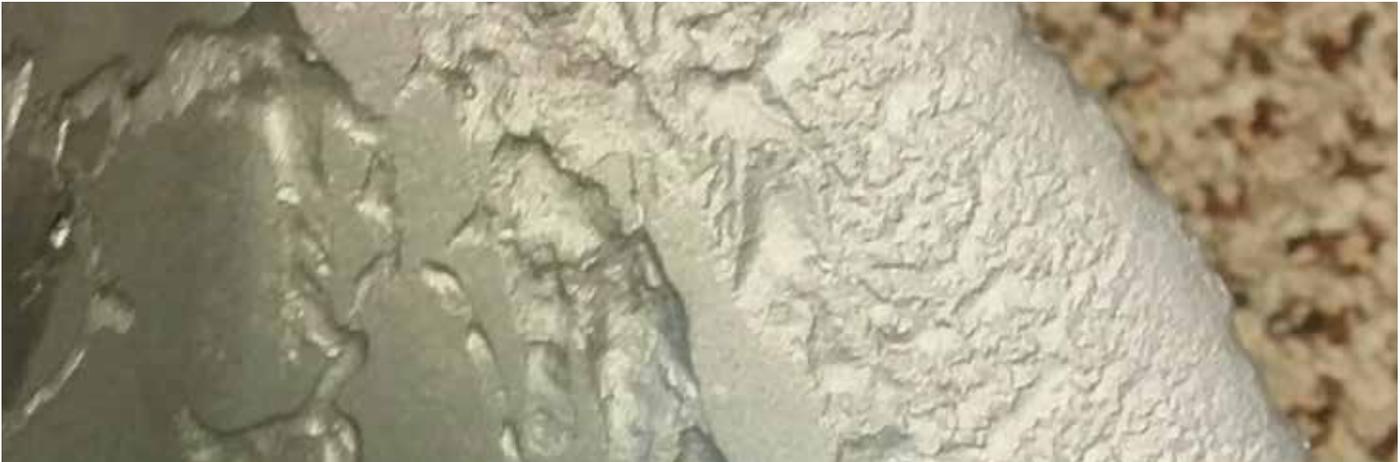
Incomplete Burn-out

Mechanism

During casting, residual carbon in the mold remaining from incomplete burnout react with molten metal producing CO. The CO, in the form of a gas bubble, prevents the metal from filling the area

Smooth irregular shaped voids generally in or just under the cast surface usually irregular in outline but tending to assume a spherical or wormlike shape. The casting surface may exhibit a matte finish in the area of the defect

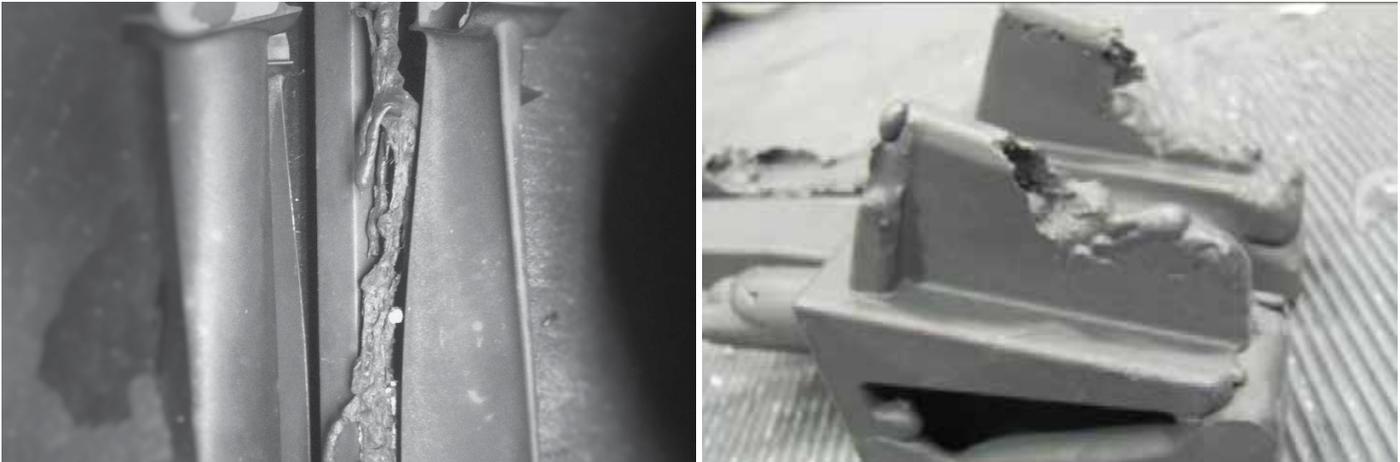
Mechanism

Metal leaks out of the mold during or immediately after casting

Smooth in most instances, but also be rough. It could be irregular. Many features or runners missing because of lack of metal. May have a positive fin where the leaker occurred.

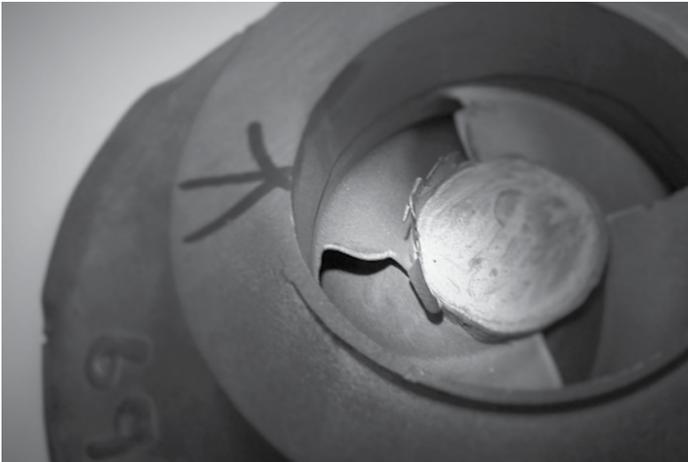
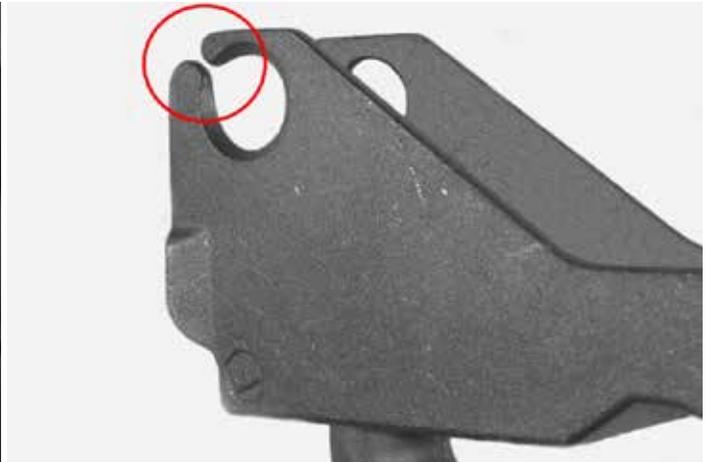
Non Fill

Mechanism

During casting, the metal freezes before mold cavity is completely filled out

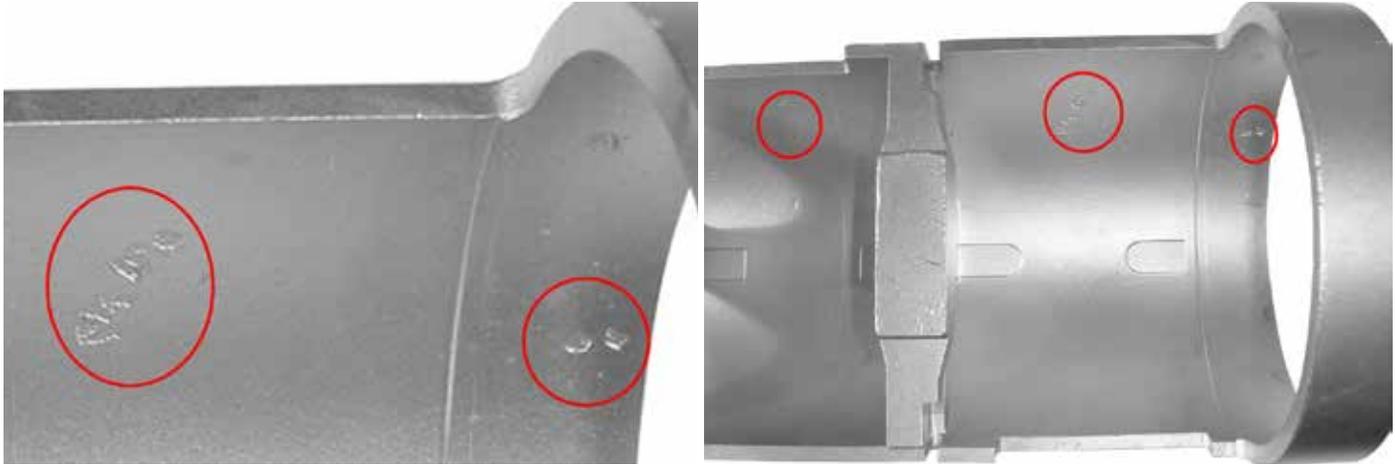
Non-Metallic Inclusion

Mechanism

Foreign material in the mold cavity which can originate either from the mold or from outside the mold. The shape of the defect aids in determination of the source

Generally a smooth sided irregular negative shape of indefinite size. Inclusions caused by ceramic material are usually more angular and may contain bits of embedded ceramic.

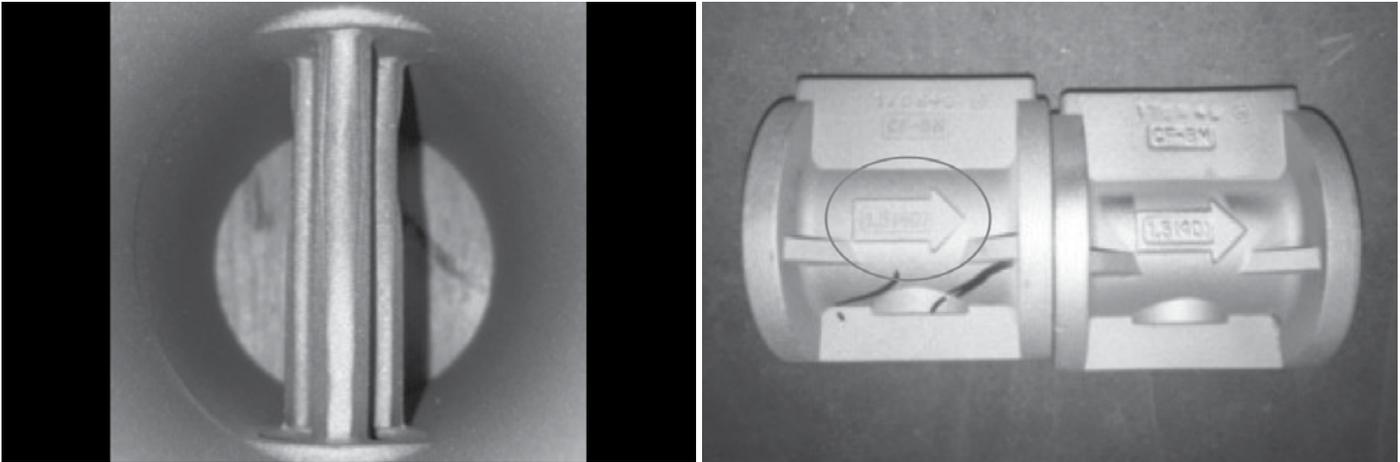
Mechanism

The blasting media used in mechanical cleaning equipment is typically harder than the casting. The surface of the casting can be deformed or eroded by extended blasting time or excessive blasting energy.

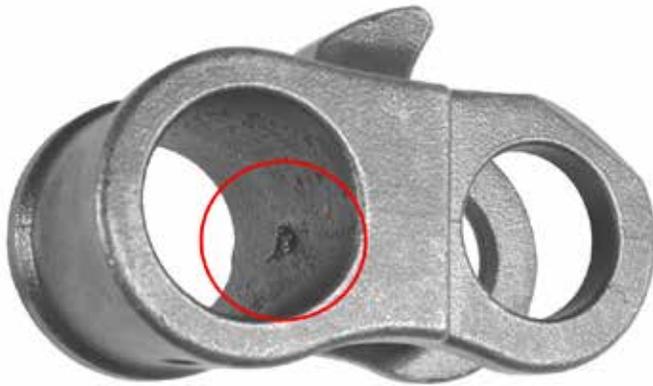
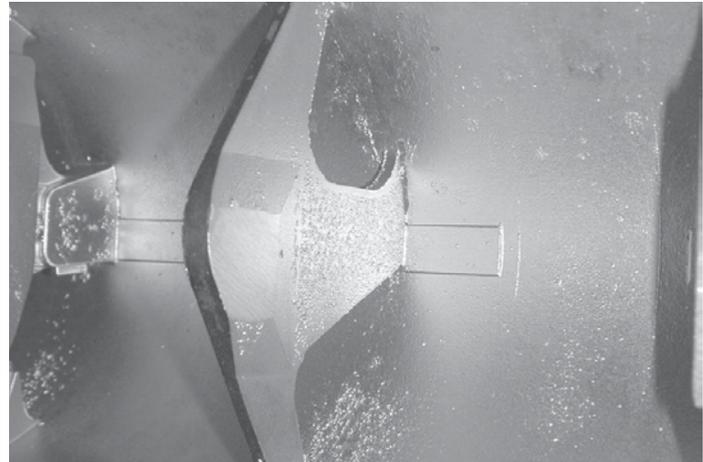
Penetration

Mechanism

Metal penetrates into the primary layer during casting. Pinholes or air pockets in the primary layer fill with metal during casting

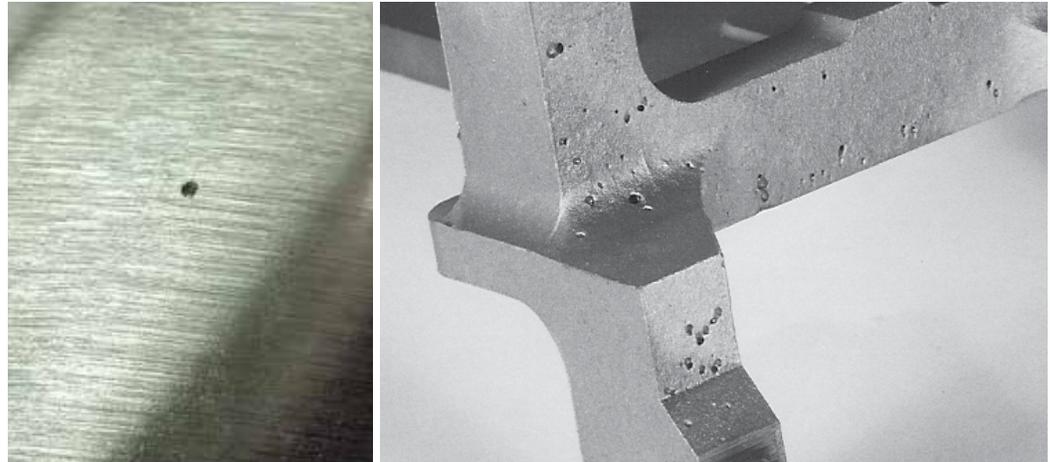
Gases are absorbed in metal during melting. If the gas level in the melt exceeds the solid state solubility limit, bubbles are formed during solidification. The gases most responsible for this defect are hydrogen and nitrogen.

Chemically combined water in the mold is released by the increase in mold temperature during casting.

Pinhole defects are typically smaller with a higher frequency than gas, slag or incomplete burn-out. This defect is more common in plain carbon and low alloy steels than in higher alloy steels.

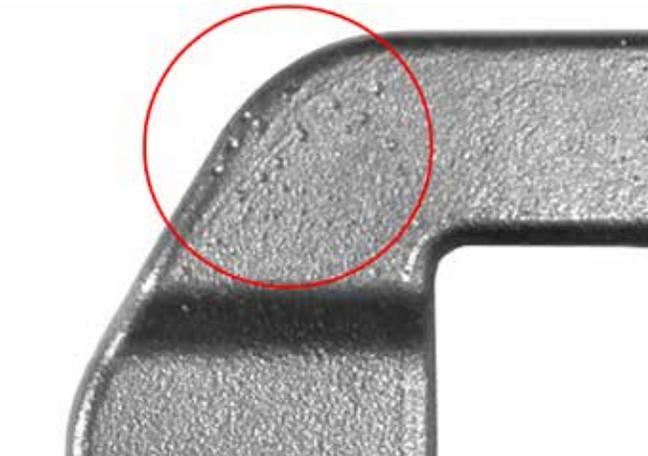
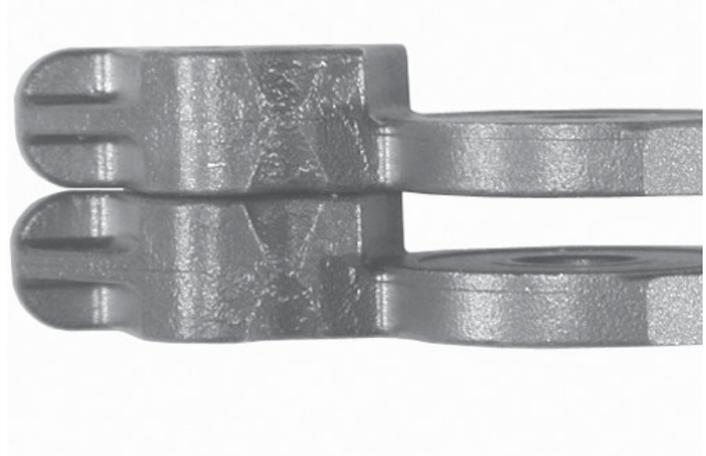
Pitting

Mechanism

Oxygen reacts with chrome in the metal immediately after casting

Can only occur in high chrome alloys such as 400 series and PH stainless steels

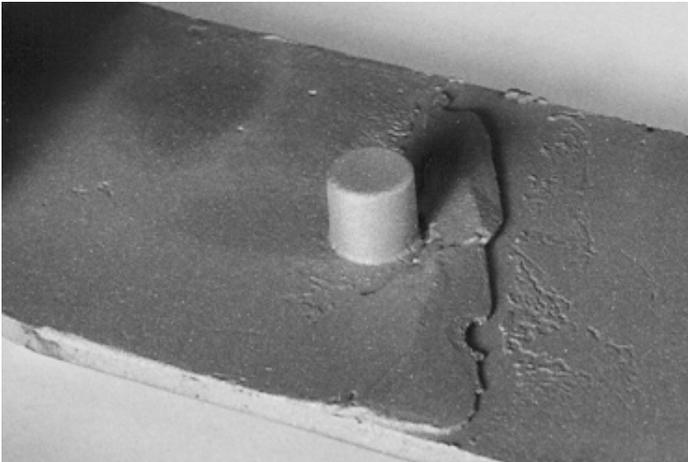
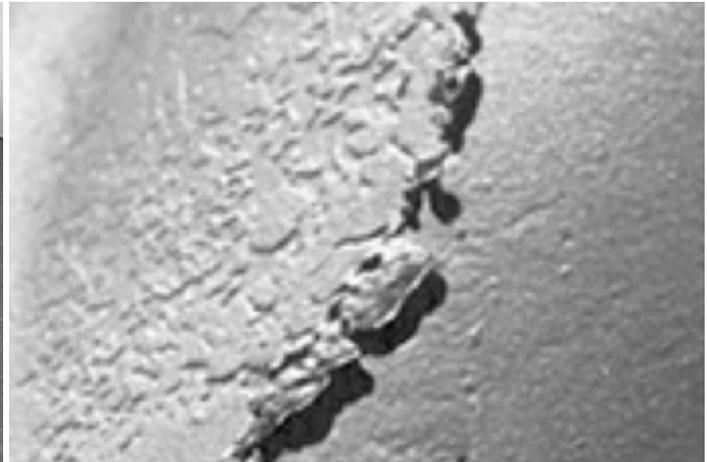
Mechanism

During shell building, the primary coat cracks and lifts off the pattern. Subsequent slurry layers penetrate and fill the gap between the pattern and the primary coat. This defect is a close cousin to buckle

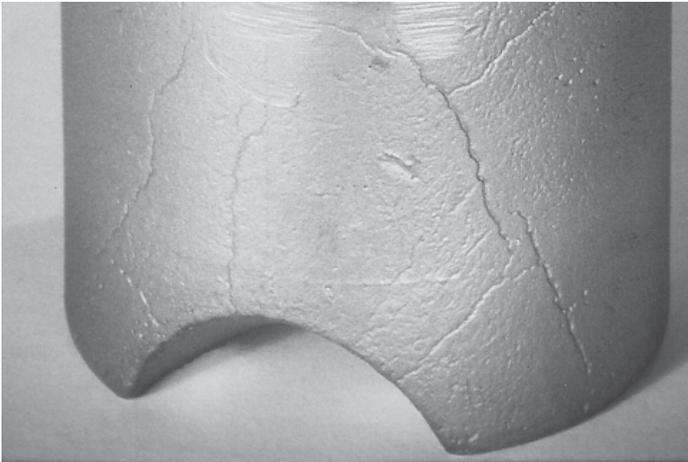
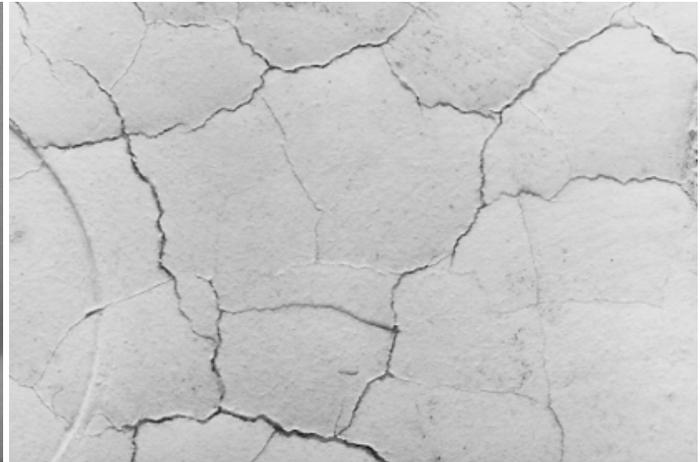
Mechanism

This defect is a marriage of pitting and finning defects. Rat-tailing is the selective oxidation of the metal surface through cracks or micro-cracks in the shell. Most of the cracks are large enough to be filled with metal during pouring and will produce positive metal fins. Very fine micro-cracks are too small to allow metal to enter, but will allow air (oxygen) to reach the hot casting surface.

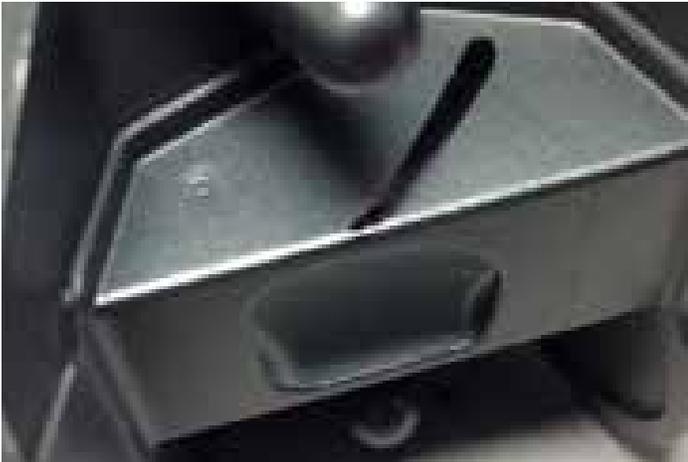
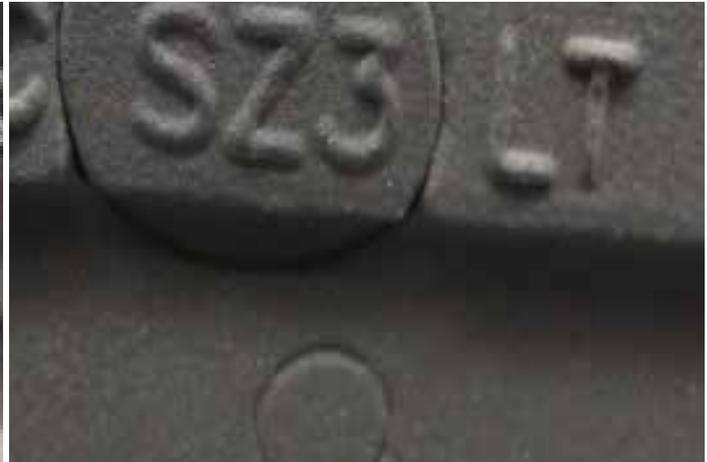
Mechanism

During casting, droplets of metal detach or are separated from the pouring stream by excessive turbulence, mold design, or metal pouring height. The metal droplet becomes either cooler in temperature or coated with a tenacious oxide film and retains this identity as part of the cast metal.

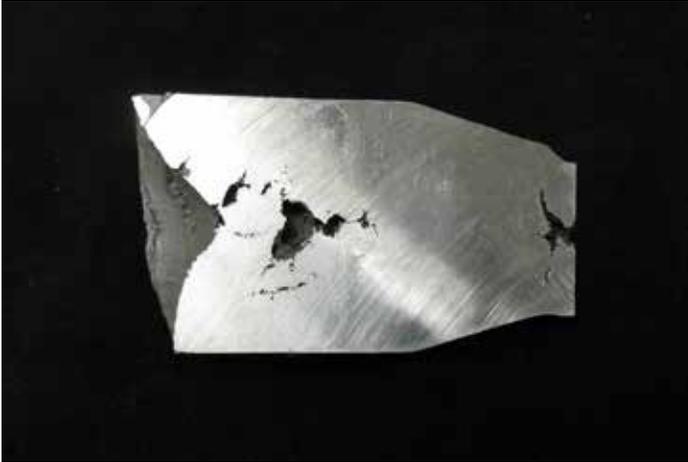
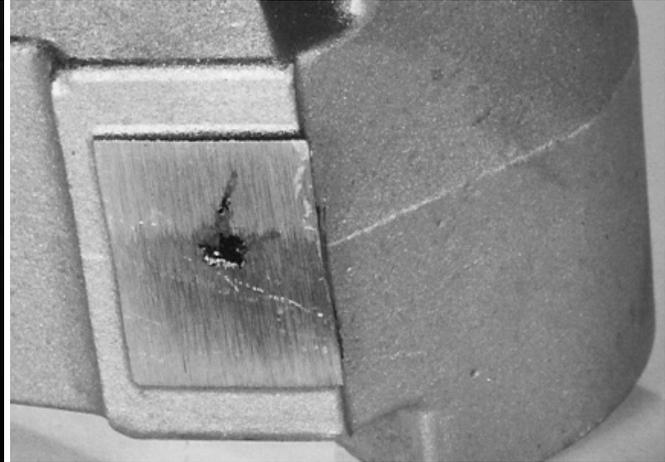
Shrink - Gate

Mechanism

The molten alloy shrinks as it solidifies. Inadequate feed metal from the gating system is available to prevent a cavity from forming.

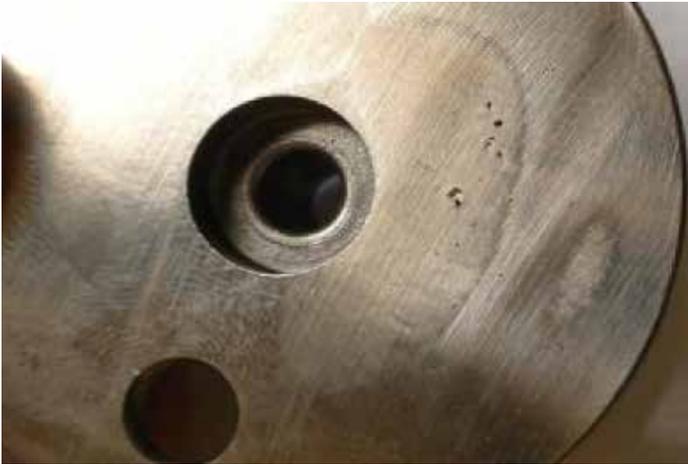
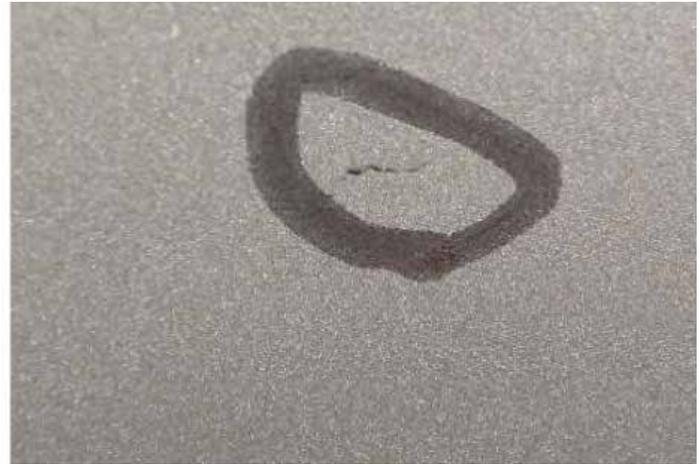
Shrink - Internal

Mechanism

Molten alloys shrink as they solidify. As solidification progresses and the solid to liquid fraction increases, it becomes more difficult for liquid feed metal to reach the solidification front. Shrinkage occurs between dendritic arms. In larger defects, inadequate feed metal is provided to isolated hot spots in the casting.

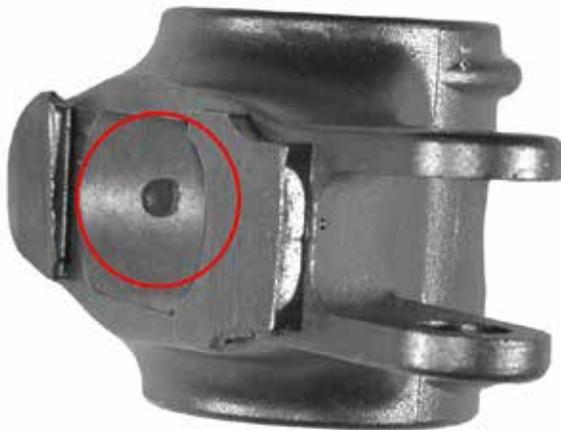
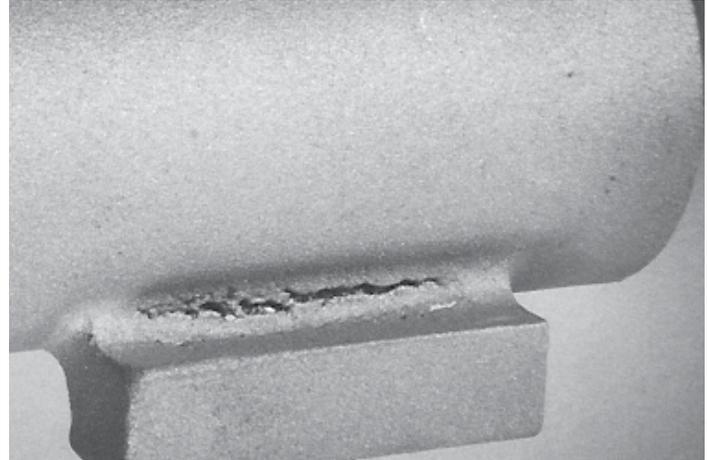
Shrink - Surface

Mechanism

The molten alloy shrinks as it solidifies. Sharp inside corners thermally saturate the shell and cool slower than the surrounding area. Unfavorable thermal geometry resulting in an isolated liquid metal heat center. The shrinkage of the internal section, cut off from supplies of further liquid feed metal, causes atmospheric pressure to collapse the adjacent skin where the metal is still sufficiently hot and weak to do so.

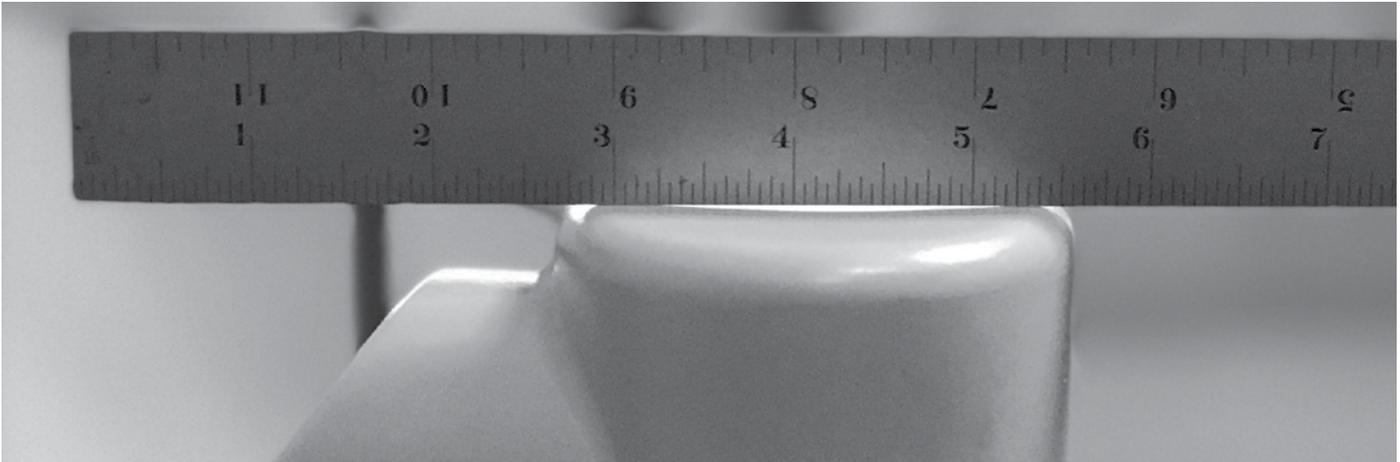
Mechanism

Heavy section of wax pattern shrinks as it cools. The vacuum created during cooling causes the surface to cavitate or dish inward.

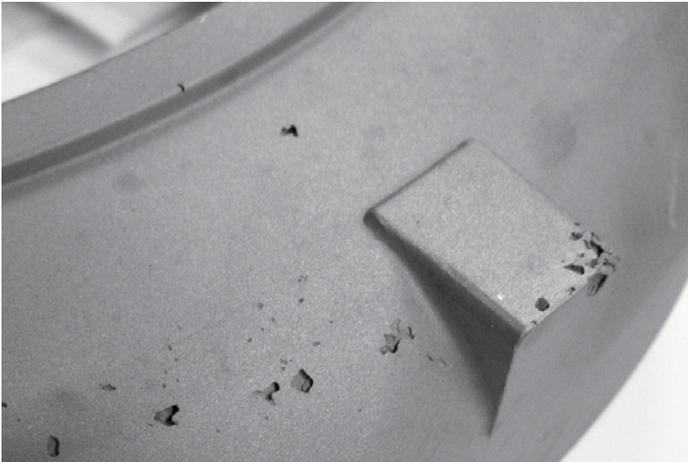
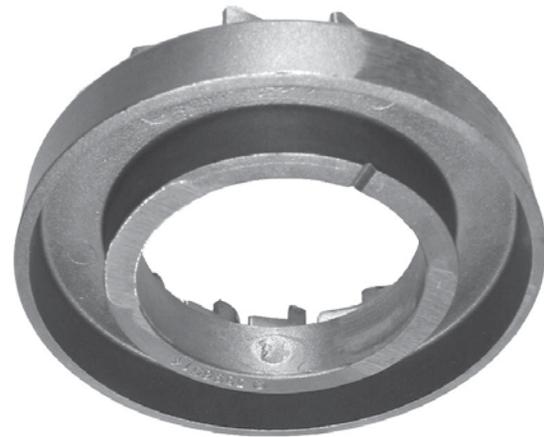
Mechanism

During melting or casting, slag is produced as a function of time, temperature and availability of oxygen. This slag is mixed with the metal during pouring and, being less dense than the metal, floats to the top surface of the casting.

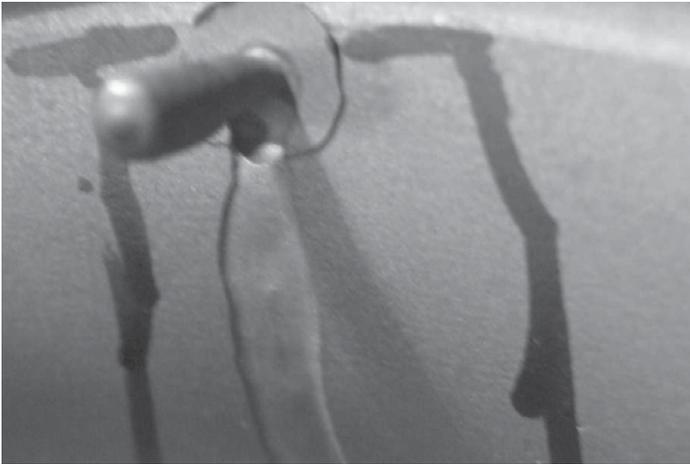
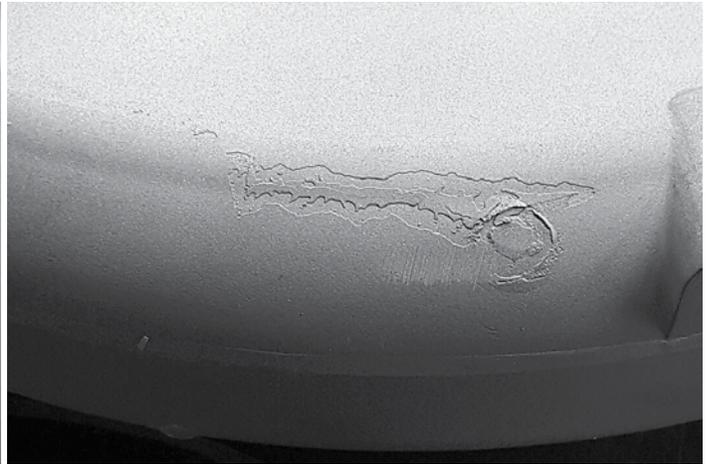
Slurry Leakage

Mechanism

Liquid ceramic slurry enters the mold and dries creating a positive in the mold that is represented as a negative in the casting
