An Investment Casting Institute Publication

Atlas of Casting Defects

December 2017

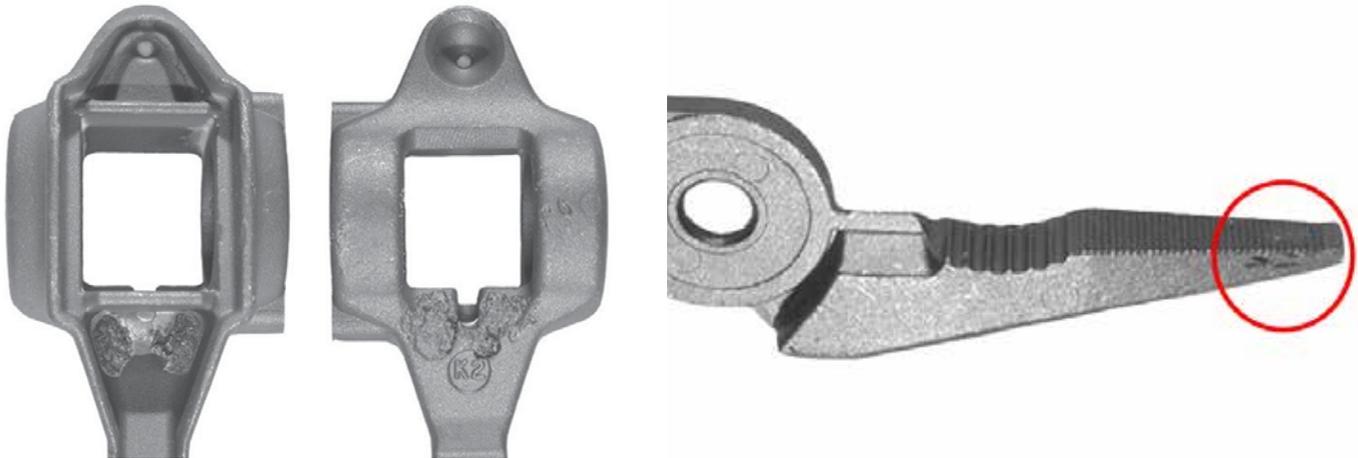
Spall

Mechanism

The layer to layer bond in the shell construction is not strong enough and the ceramic fractures off the mold surface during dewaxing, mold preheating or casting and falls into the mold cavity

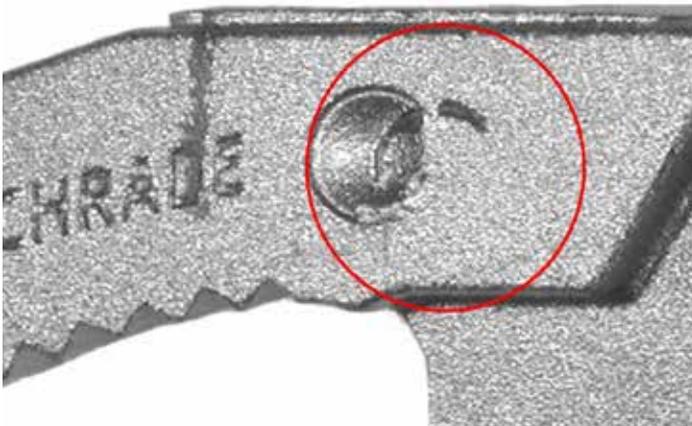
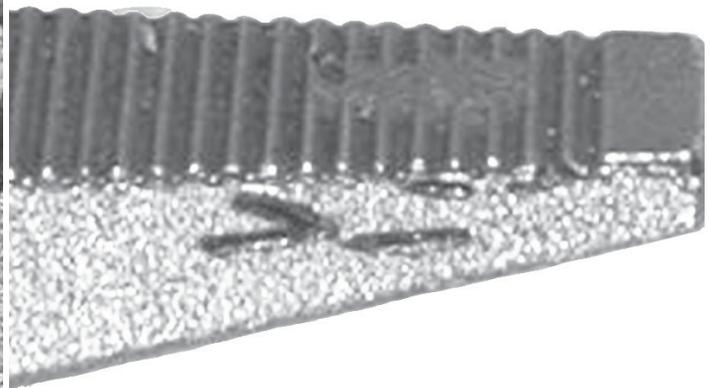
Spall

Sharp or irregular positive defect normally accompanied by a negative defect (inclusion) from the ceramic that has “spalled” off and appears somewhere else on the casting.

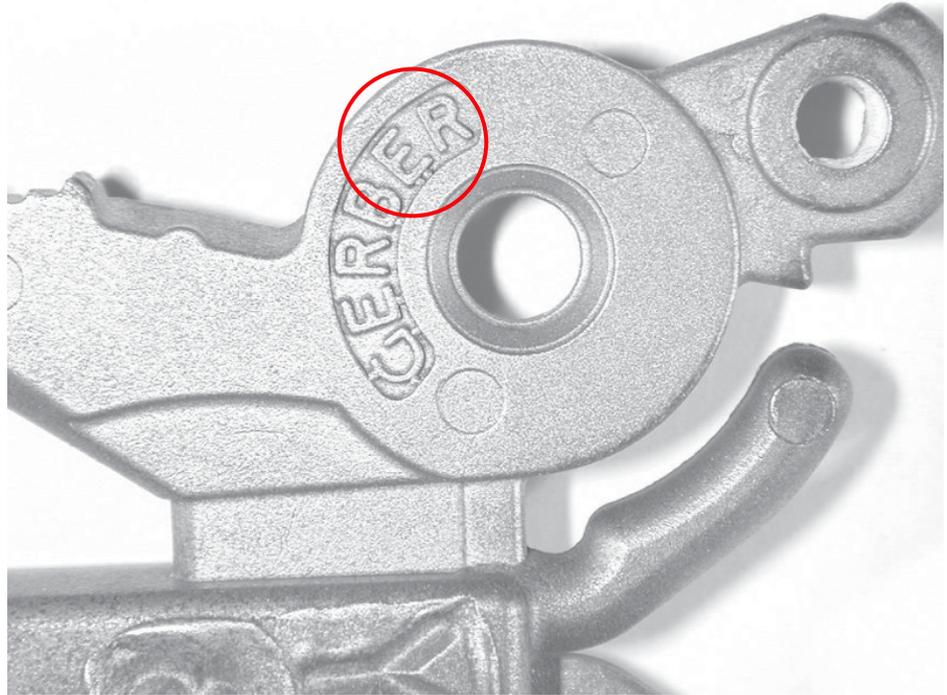
Stuck Shot

Defect Type
Positive

Aliases
Positive metal

Method for defect determination
Stuck shot can be pried out. Can also section, mount and polish through defect. Stuck shot will not be attached to the casting – only wedged in place

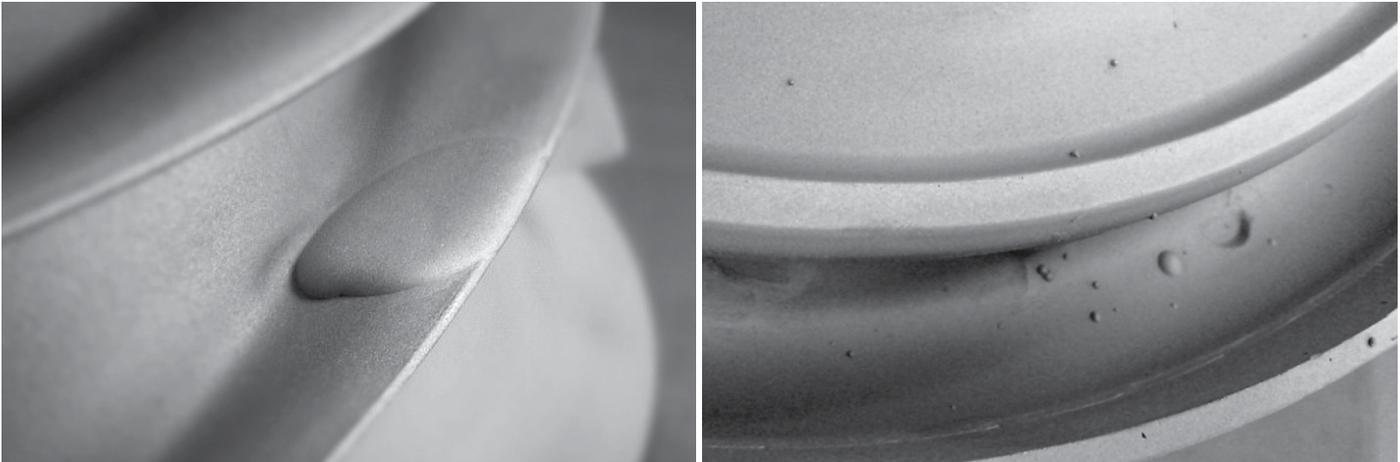
Wax Drip

Molten Wax or sticky wax drips onto the pattern during gating assembly process
