Atlas of

Casting Defects

Investment Casting Institute

Introduction

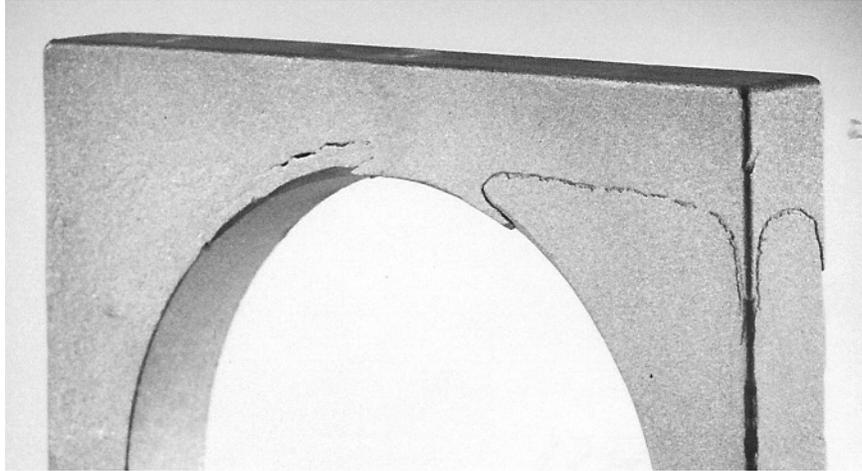
Defect: Cold Shut

Appearance of Defect: Linear indication of metal not joined at time of two metal streams meeting.

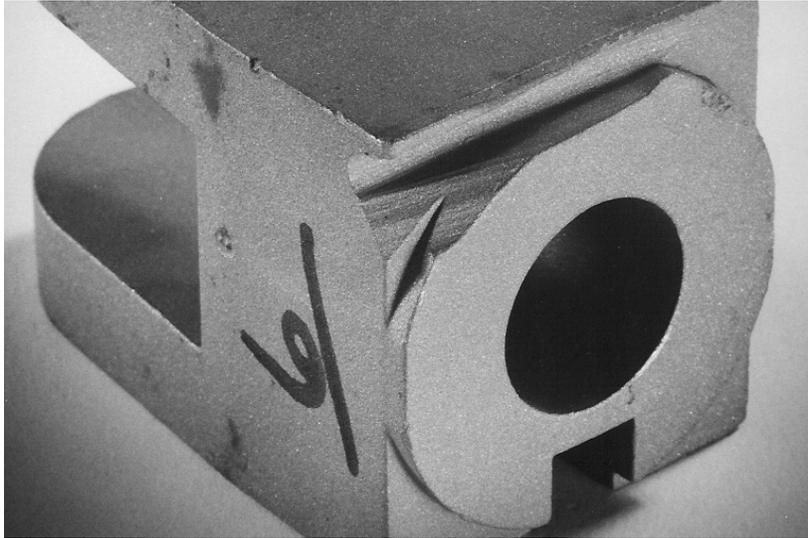
Defect: Cut Off Damage

Metal removed during gate cut-off with evidence of abrasive wheel and/or saw damage to casting.

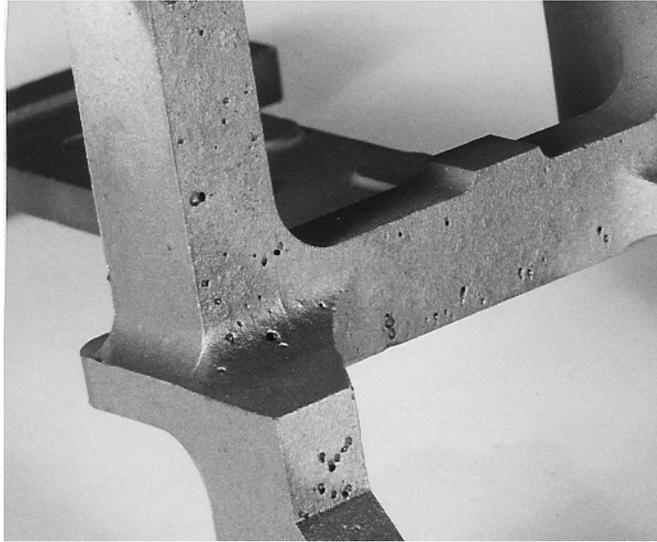
Defect: Gas

Generally spherical or teardrop shaped cavities which may or may not contain evidence of oxidation.

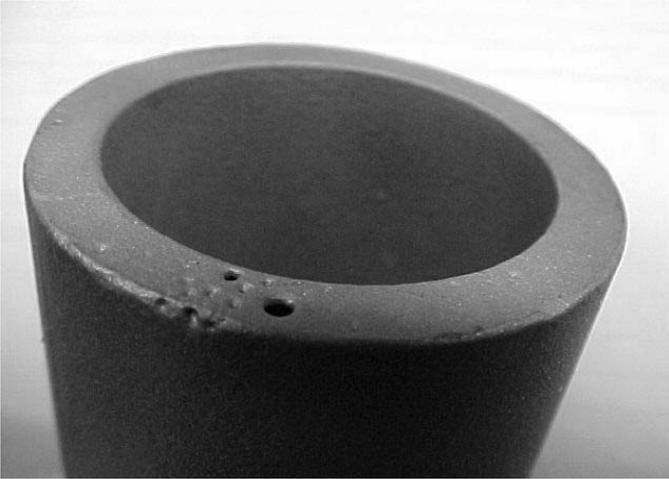
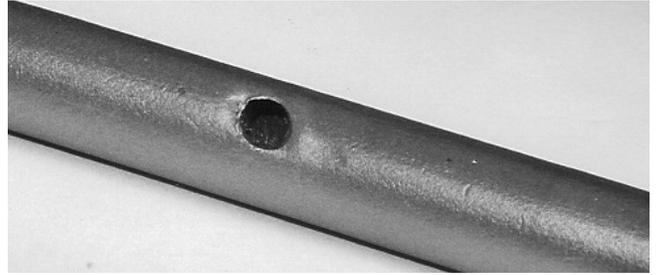
Defect: Gas (Air Entrapment)

Rounded smooth walled cavities which may exhibit a slightly oxidized surface.

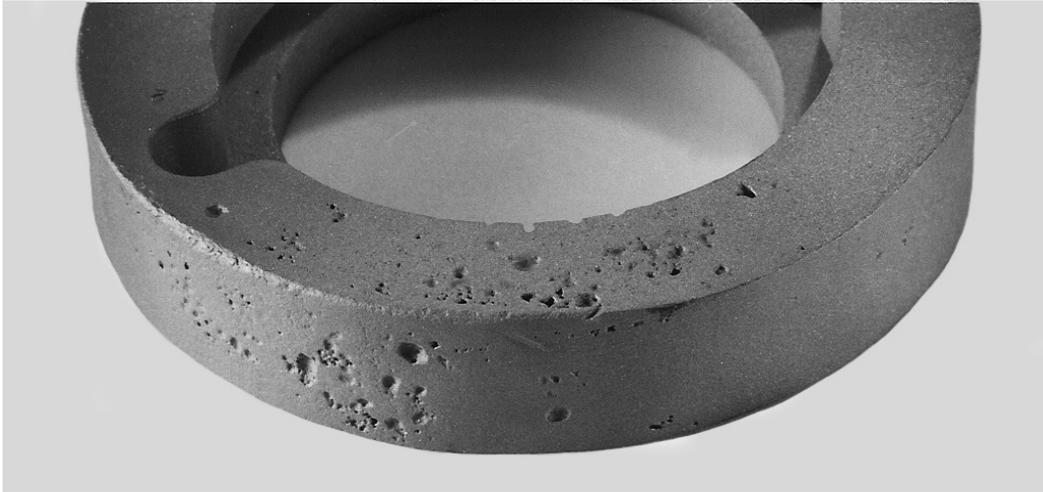
Defect: Slag

Appearance of Defect: A series of cavities of irregular and symmetrical shape indicative of slag and/or refractory particles producing the irregular shapes and gas producing the symmetrical shapes.

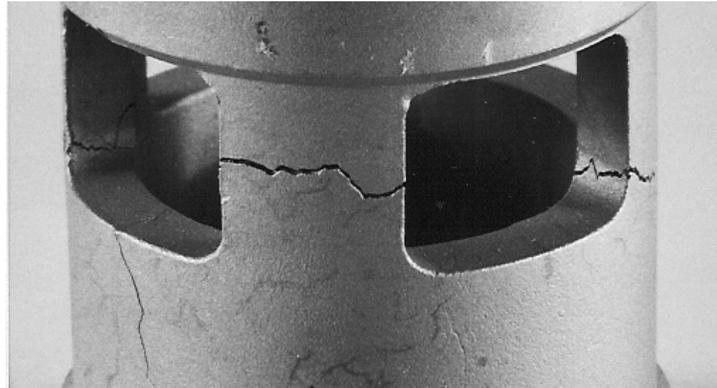
Defect: Hot Tears

Intergranular crack exhibiting oxidized fracture interface.

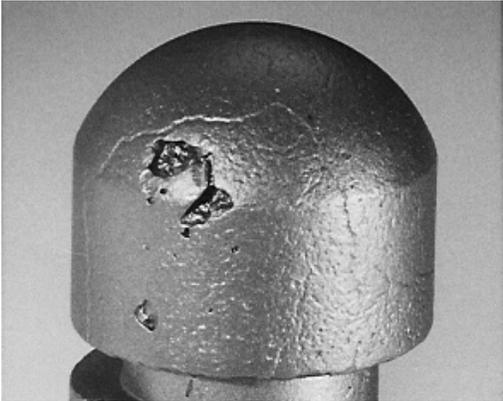
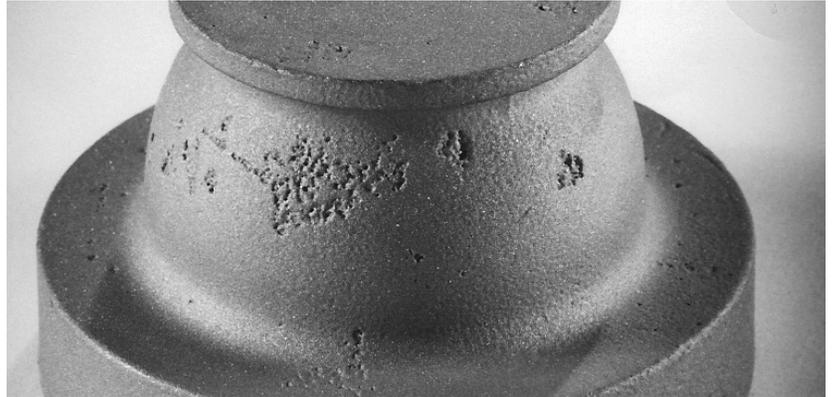
Defect: Inclusion

Appearance of Defect: Irregular cavities possibly containing traces of refractory and/or slag particles.

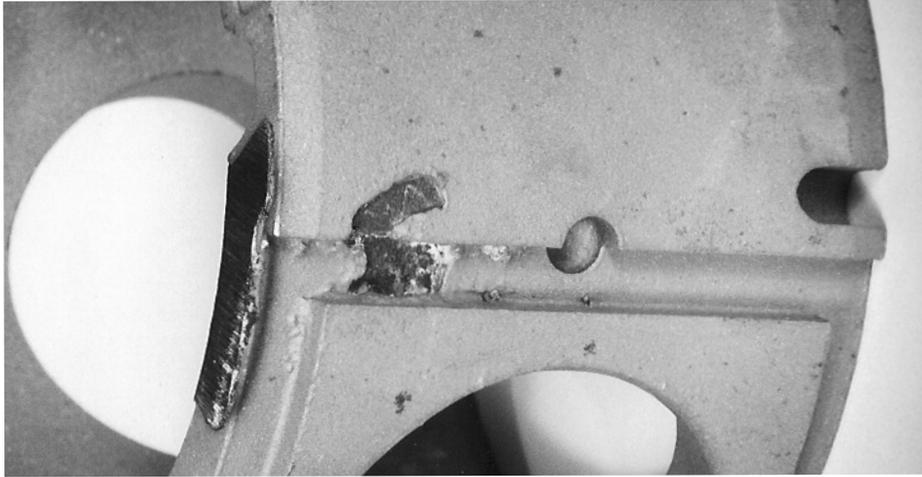
Defect: Ceramic Inclusion

Generally a smooth sided irregular shape of indefinite size possibly containing traces of refractory material.

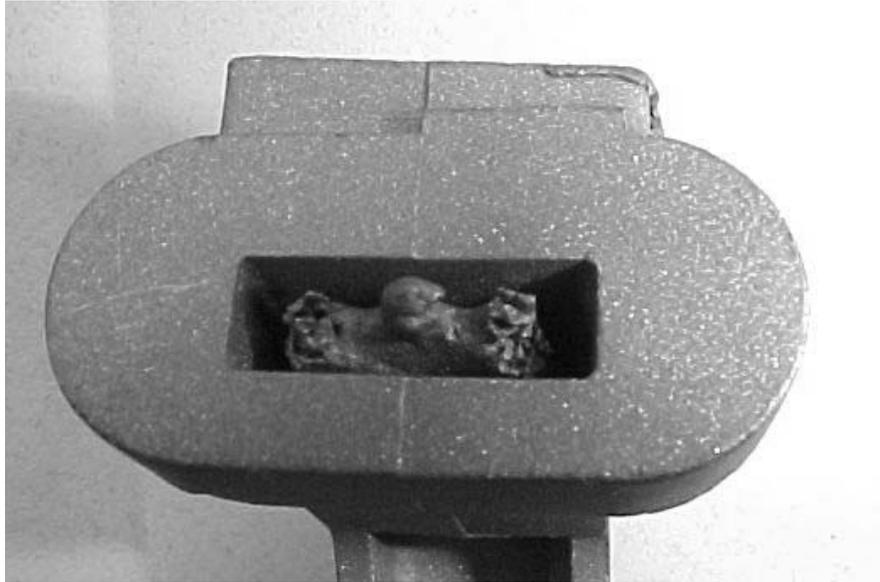
Defect: Excessive Metal From Shell Failure

Generally a smooth sided irregular shape of indefinite size possibly containing traces of ceramic material with angular irregular shape in vicinity of shell failure.

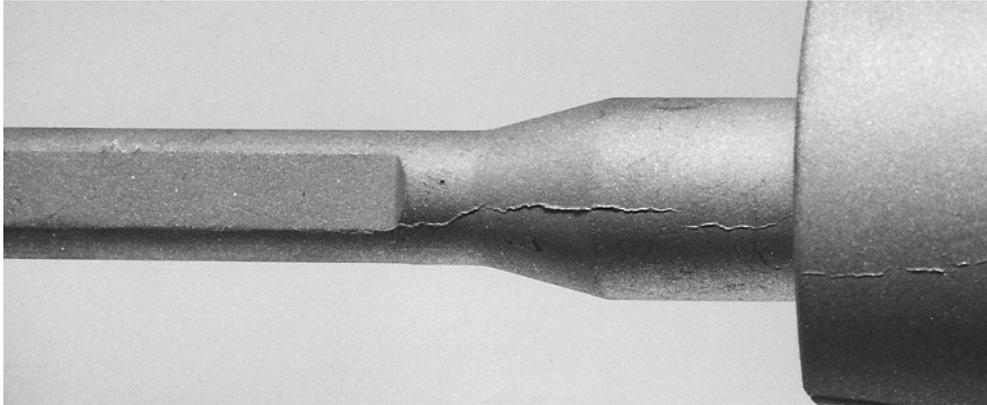
Defect: Mold Cracking, Finning

Surplus metal following contour of crack in shell mold.

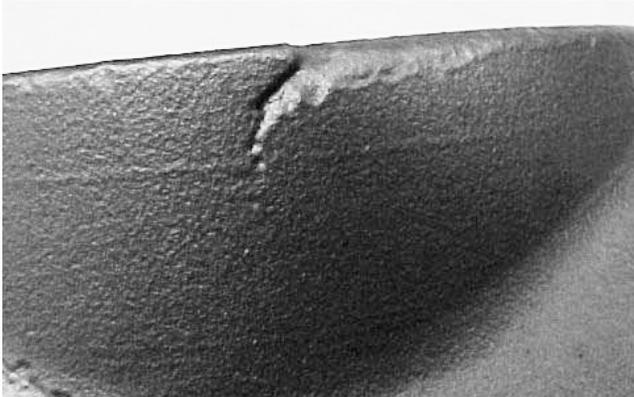
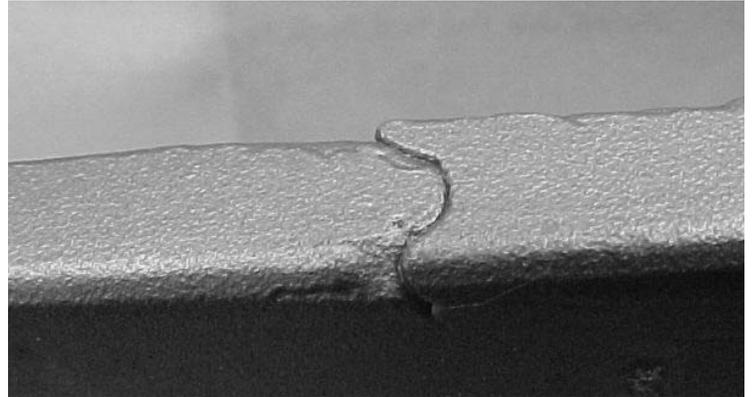
Defect: Non-fill/Misrun

Incomplete casting with rounded edges where casting is not completely filled.

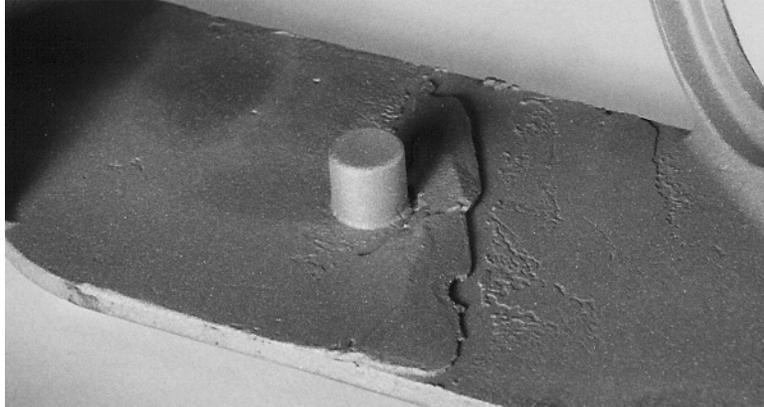
Defect: Primary Coat Buckle

Island of surplus metal on surface of casting, often associated with flash at the casting edge.

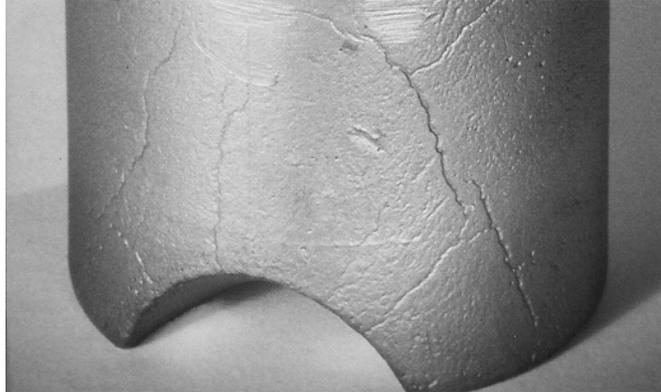
Defect: Rat-Tailing/Oxidation Crazeing

Shallow rounded grooves on the surface of the casting with radial pattern (oxide may be evident in the grooves prior to cleaning).

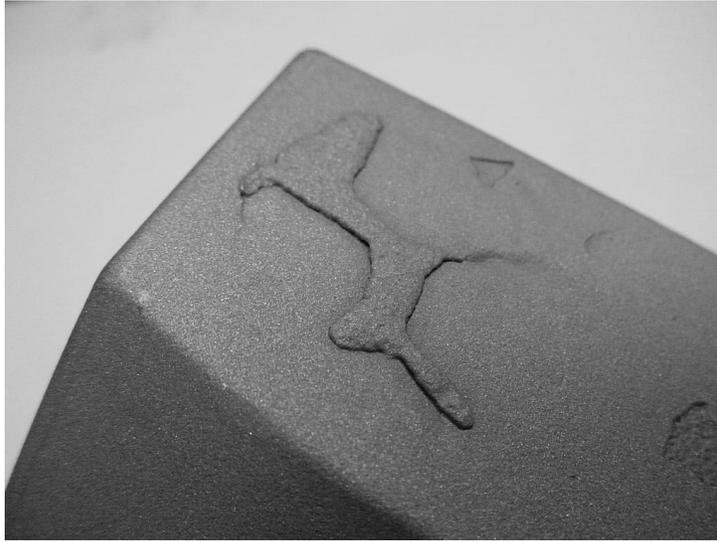
Defect: Shell Buckle

Metal penetration in area designed for core along with evidence of mold cracking prior to casting (note small fin).

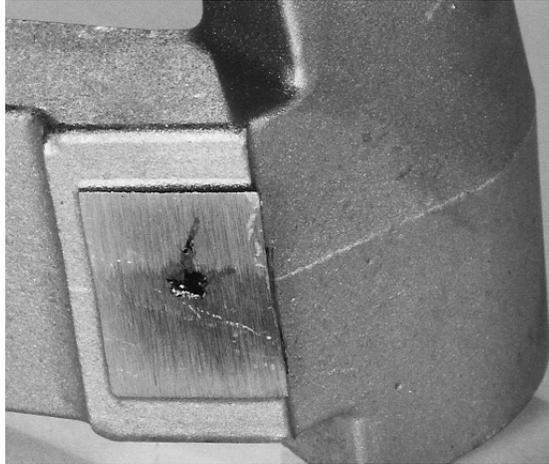
Defect: Shrink in Gate Area

Large internal irregular cavities usually exposed on removal of gate.

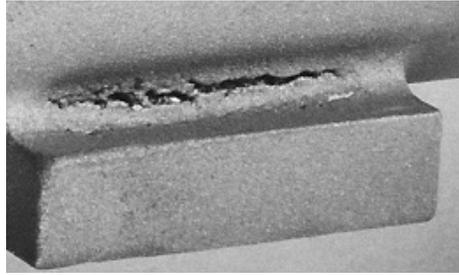
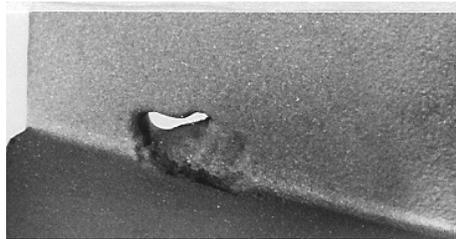
Defect: Shrinkage (Surface)

Appearance of Defect: Surface depression or irregular cavities exhibiting oxidized surfaces.

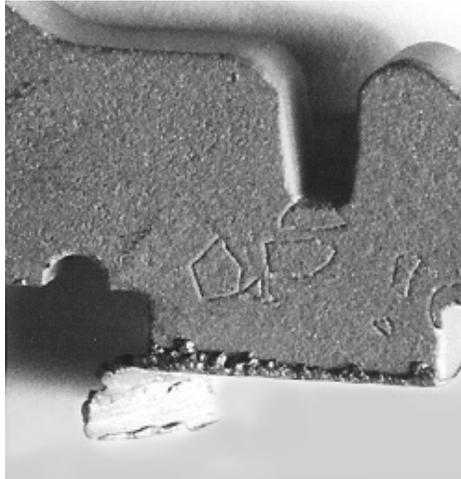
Defect: Wax Flow Line

Casting shows irregular smooth shallow grooves reproducing detail of pattern lines.
